**AN ARCHAEOLOGICAL INTERPRETATIVE SURVEY
OF
OLD KENT COTTAGE, FROGHOLT, KENT. CT18 8AT
(NGR TR 177 375)**

Report No. 2011112

Project No. 4927

May 2011

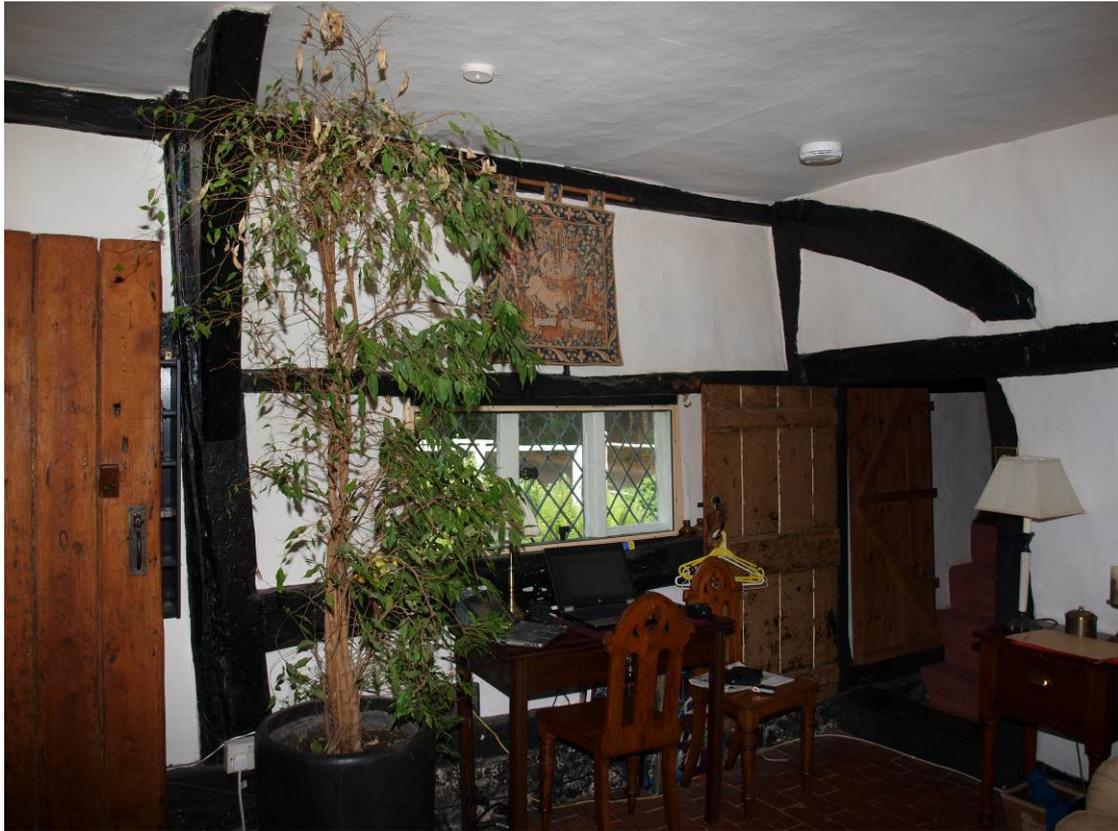
- 7.1.7 Elements of the hall window are retained within the high-end hall bay (Bay 2 – Fig.3) of the west elevation. The location is re-used for the present window but features of the original do survive. The sill and the transom are still *in situ* although the transom is only visible from the interior and is formed by the side girt. Later reduction in the size of the window and re-use with the smaller *in situ* window has obscured details of the form of the original window. However, the central stud may be the remains of the king

mullion, and the two studs to either side of the present window extending from sill to plate may be the original jambs, giving the hall window a central location within the high-end bay as is usually the case. The rebuilding on the east side, of the ground floor elevation in brick has resulted in the loss of the opposite hall window.

Plate 1: Interior view of west wall of hall (Bay 2)

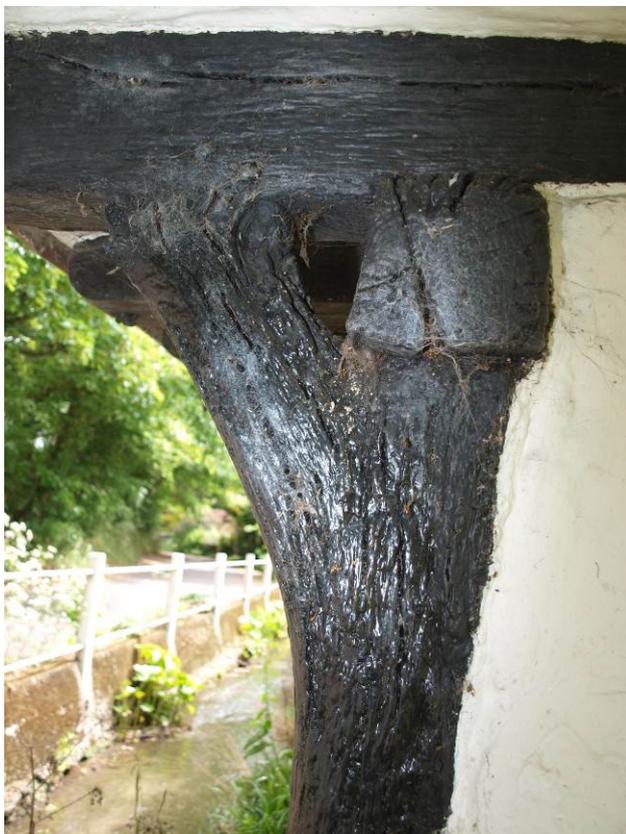
note in that the three principal posts: one at each corner and a central member, are naturally forked timbers, chosen due to their shape to serve a specific function. It is usual in such buildings for a post to include a brace linking them to the corresponding jetty joists that extend beyond the ground floor of the building to support the projecting floor above. In this example, the timbers are forked naturally to provide post and integral brace rather than being composite in construction (Plate 2). The feature indicates a good working knowledge of woodland management and carpentry combining the two in response to the requirements posed by jetty construction.

Plate 2: Naturally forked timber for post and brace under north end jetty west side)

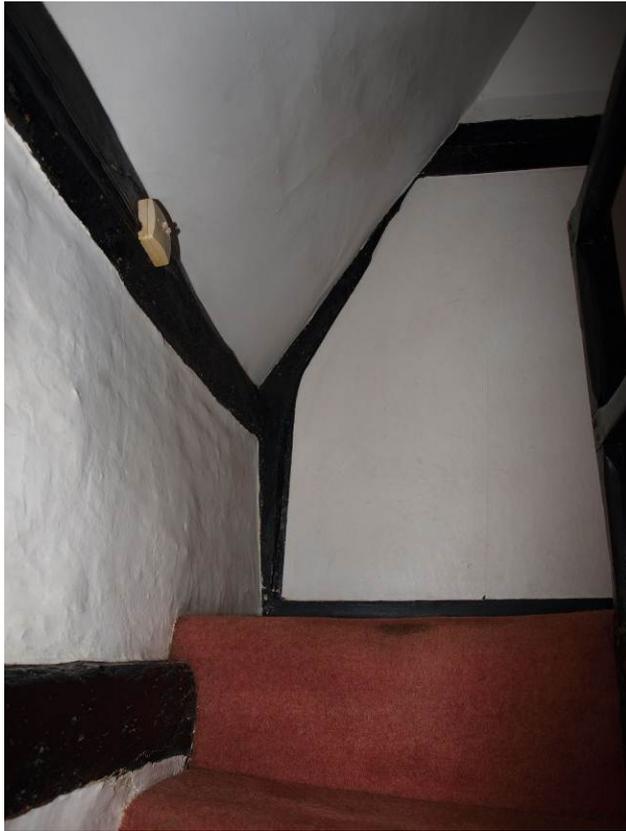
- 7.1.4 This knowledge of the materials required extends to the upper floor of the jetty. The projecting north end wall includes a pair of cranked principals (Fig. 4 and Plate 3). The members are selected with a naturally occurring 'elbow' to provide a straight lower part to provide the low walls of the loft and an angled upper part in the manner of the remainder of the rafters, to support the roof construction, which at the north end of the building was half-hipped to allow extra head-room. The cranked principals allowed for a raised tie-beam within the north elevation, again to create better head-height within the loft accommodation. There is no visible evidence for head or foot-bracing within the external wall construction.

Plate 3: Cranked principal post (west side)

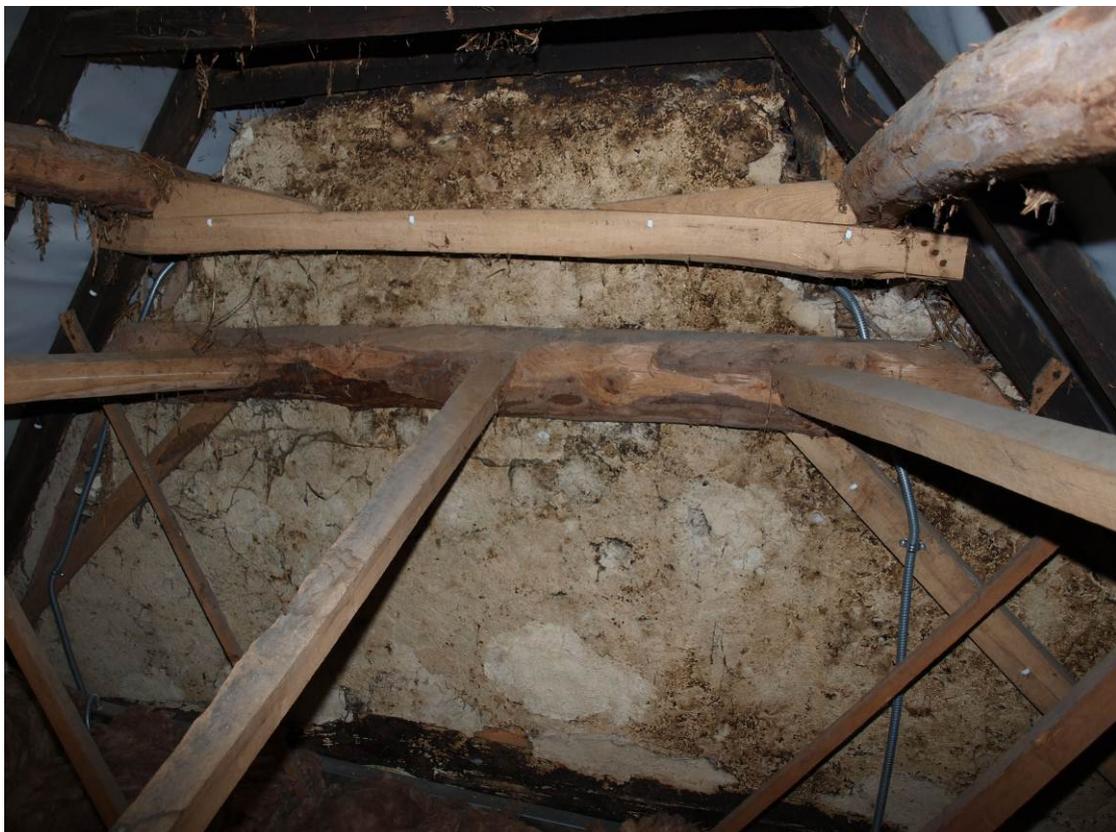
inserted, the members remained exposed but were modernised by removing the sooting formed by the archaic open hearth. The lime skim coat present on the wattle and daub of the closed north partition may also have been applied over the soot stained daub in-fill as part of this general modernisation.

Plate 4: Lime skimmed T2 truss partition between hall and high end rooms

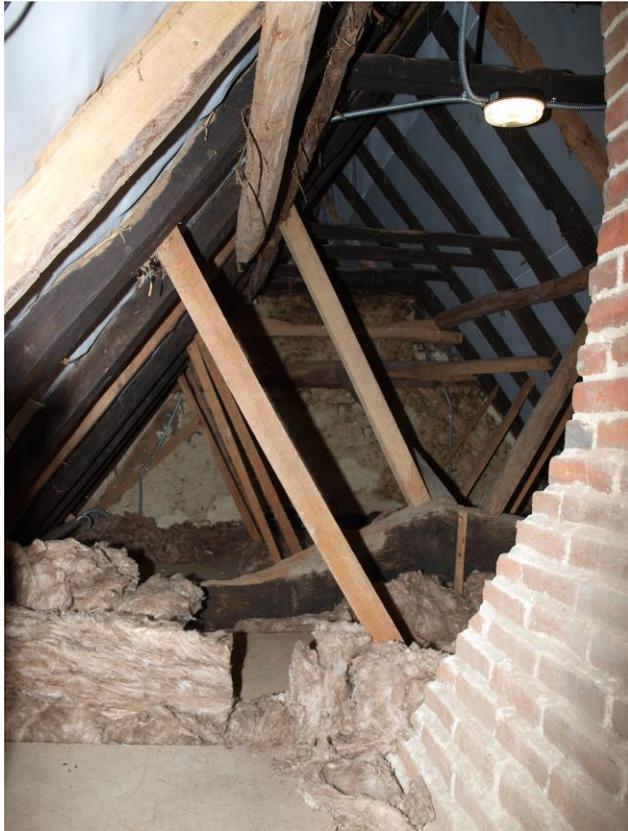
- 7.1.6 The open truss between the two hall bays comprises principal posts and a steeply cambered or cranked tie-beam (Plate 5). Tie-beam and posts are linked by a pair of substantial curved head-braces (230mm wide by 120mm thick) and it is notable that there is no corresponding principal rafter pair: the upper face of the tie-beam is clear of any redundant jointing that would indicate the presence of rafters. Decoration of the hall truss is confined to the steep camber of the tie-beam and the substantial braces (Fig. 4). Each of the members are chamfered but there are no other decorative elements. No crown post was ever situated or intended for the open truss of the hall.

Plate 5: The cranked tie-beam of the T3 truss

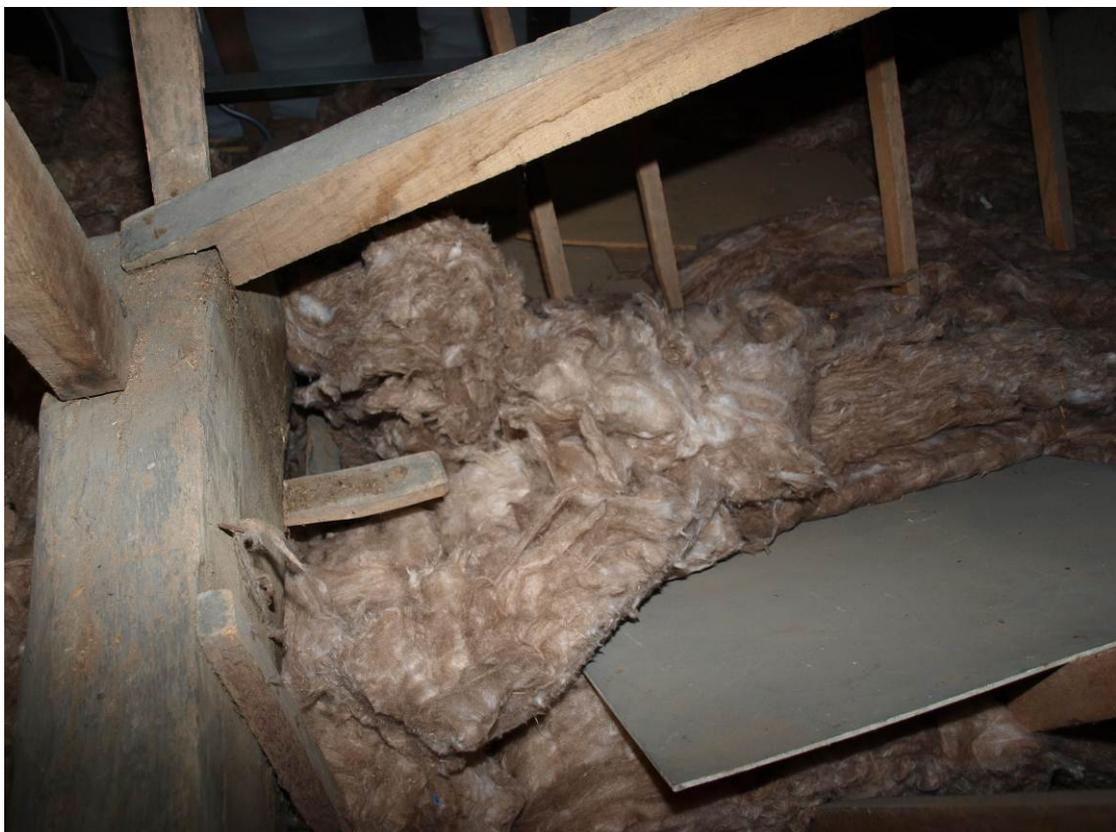
- 7.2.7 Also visible within the roof is a small timber fixture, which has been added to the soffit of the tie-beam. The fixture comprises a rectangular piece of timber with rounded end pierced by a drilled circular hole. All leading edges of the timber are chamfered (Plate 6). There is no sooting at all on the fixture which indicates that it was added after the insertion of the chimney stack. Two uses for such a timber have been suggested by David and Barbara Martin: the means of attaching a suspended light fitting, or the housing for the upper end of pole which could have served as a tethering post to prevent small children from approaching the fireplace, which not only provided the source of heating, but also required constant access for cooking.

Plate 6: Fitting for light or post end on T3 truss

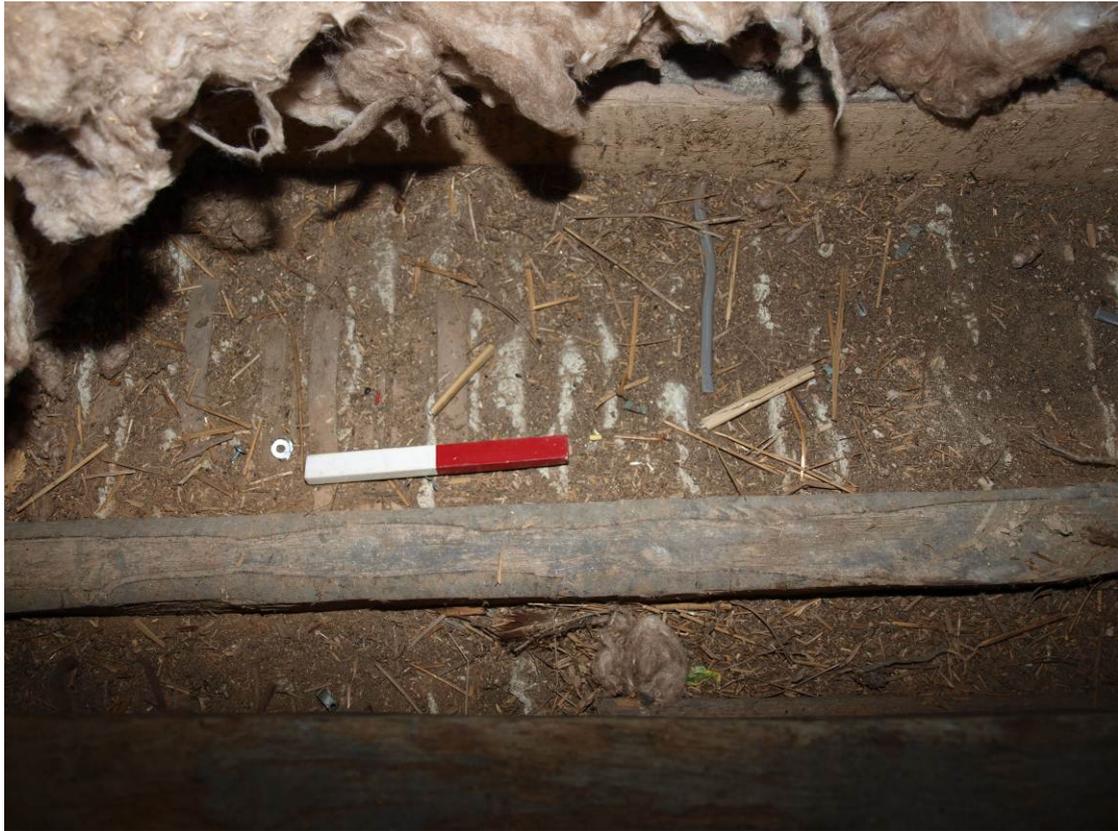
- 7.3.5 As discussed above, the ceiling was inserted into the open hall either in the late 18th or early 19th century (Plate 7). The brick floor within the hall may also date to this phase of development. The fabric of the brickwork, although worn, did not bear diagnostic features for which a date could be ascribed. Brick fabric is very difficult to date, with handmade bricks and the materials used often sourced locally, made locally, and re-used in various ways over time due to the comparatively high expense of the material.

Plate 7: ?19th century lath and plaster ceiling (20 cm scale)
